TECHNICAL REPORT REMR-CO-3

CASE HISTORIES OF CORPS BREAKWATER  
AND JETTY STRUCTURES

Report 6

NORTH PACIFIC DIVISION

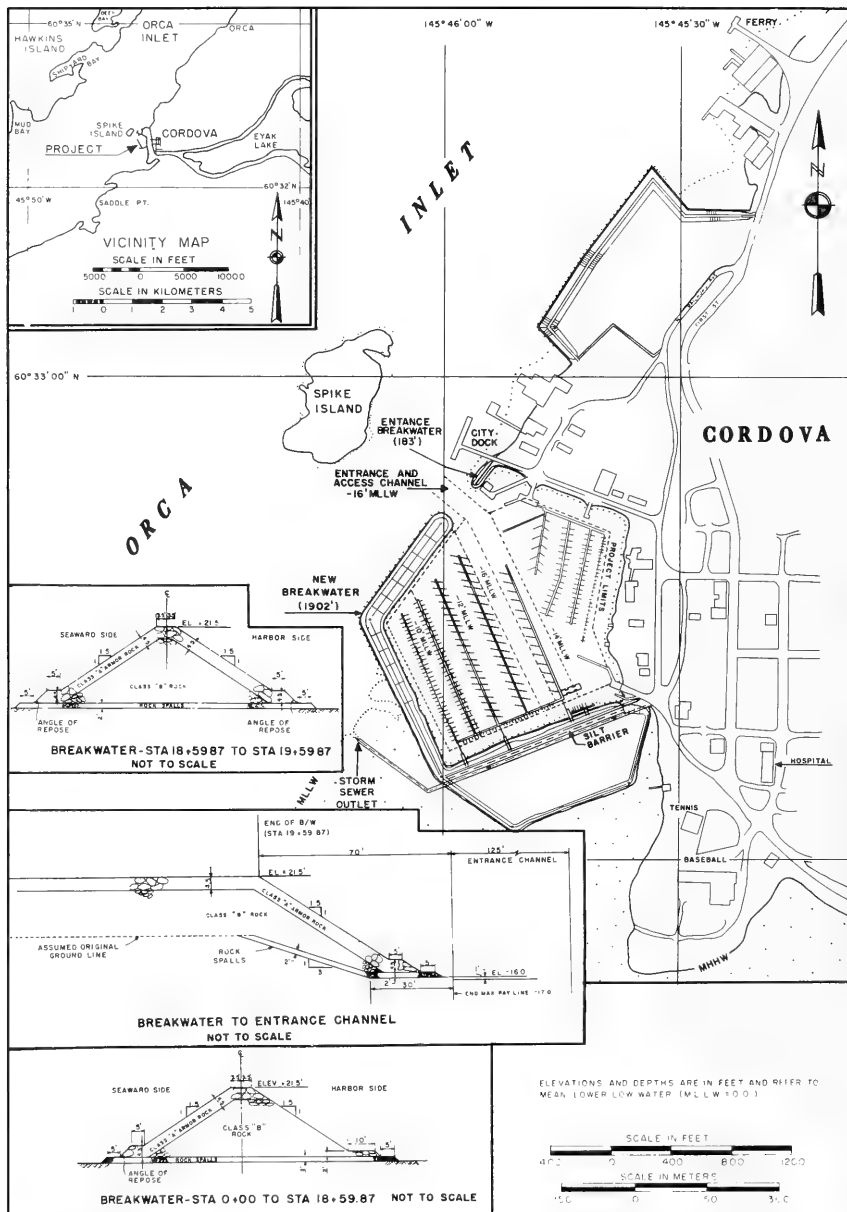
Figure 5. Site layout of Cordova Harbor, Alaska (revised 1985)

1985	The harbor is illustrated in Figure 5, and an aerial photograph of the harbor is presented in Figure 6. The breakwaters appear in good condition at this time.

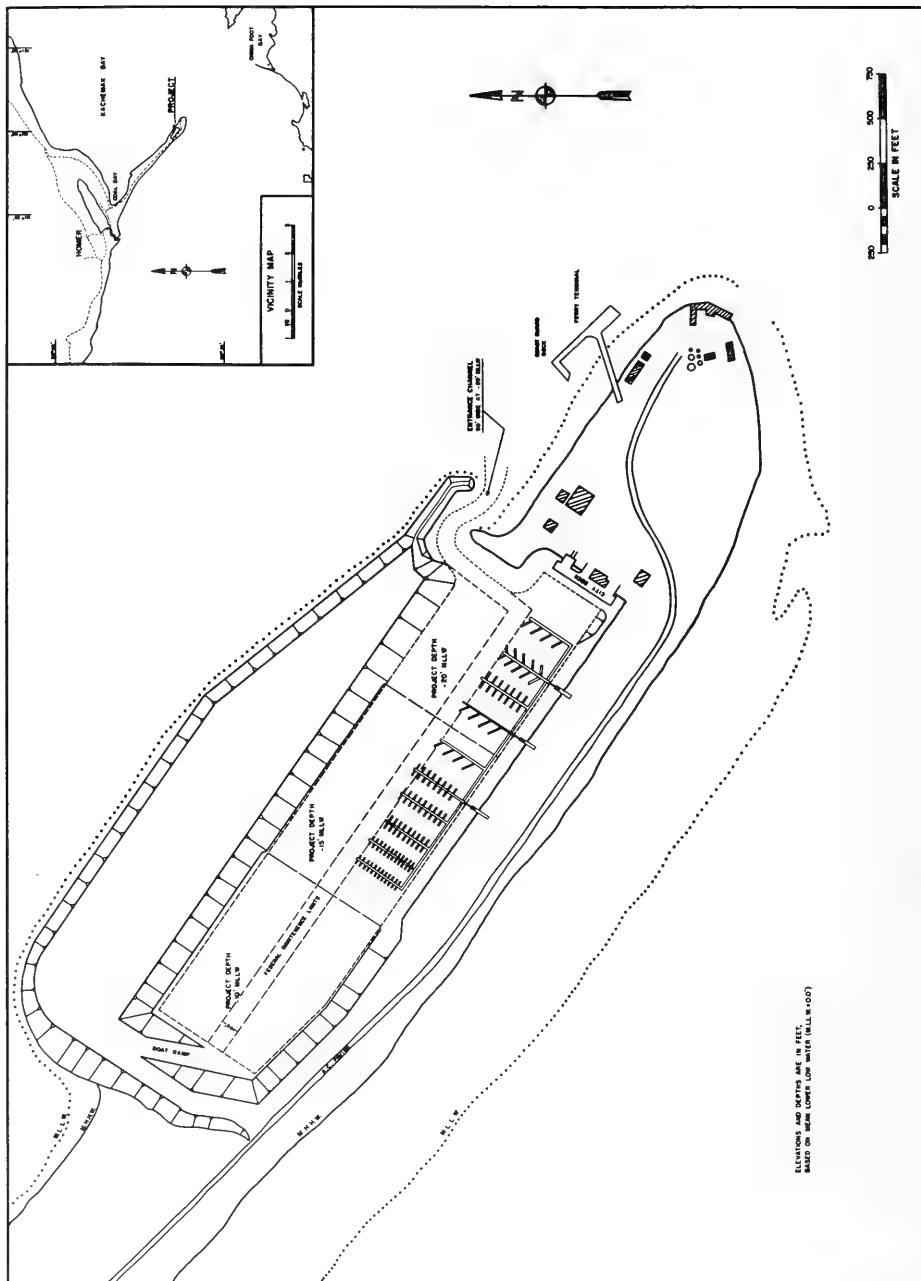
Figure 15. Site layout of Homer Harbor, Alaska, after expansion during 1984-1985 (revised 1985)

Date(s)	Construction and Rehabilitation History
	15 percent less than 250 lb), and a 4.5-ft layer of primary armor rock (Class "A", 1,100 to 3,000 lb, 50 percent between 1,500 and 1,900 lb).
1985	The breakwaters are in good condition at this time.

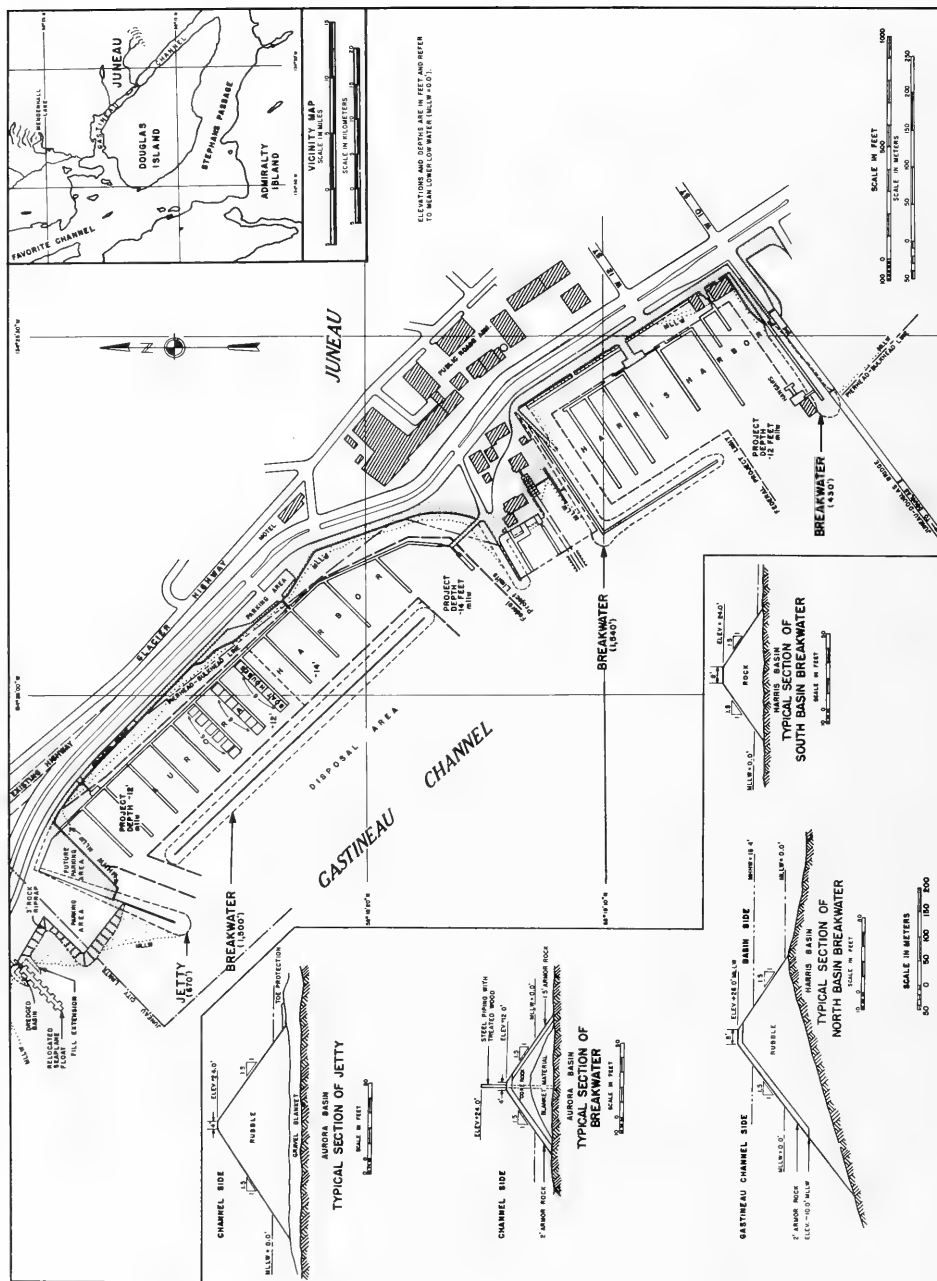
Figure 21. Site layout of Harris and Aurora Basins, Juneau Harbor, Juneau, Alaska (revised 1981)

Date(s)	Construction and Rehabilitation History
	<p>+1.5 ft mllw, and a layer of quarry rock with 50 percent weight of 15 to 500 lb. The quarry rock was covered with a 2-ft-thick layer of armor rock on the crest, channel side, and around the ends, and a 1.5-ft-thick layer of armor rock on the basin side. The armor rock had a 50 percent weight of 40 to 500 lb, with a maximum of 1,000 lb. The rubble mound had a crest width of 4 ft and 1:1.5 side slopes. The rubble mound was placed after the steel pilings were driven to 24-ft penetration. The pilings were driven on 6-ft centers and covered with 3- by 12-in. creosote-treated planks. The planks required a 2-in. thickness to prevent damage from wave action, but 3-in. thickness was used to prevent damage from boats. The maximum expected wind-generated wave was 1.7 ft, the maximum expected boat wake was 2 ft; therefore the design wave was a 2-ft, nonbreaking, short-period wave. The breakwater required 30,450 cu yd of rock and 8,820 linear ft of steel piles. Breakwater cross sections are shown in Figure 21.</p>

1985	<p>The harbor is illustrated in Figure 21, and an aerial photograph of the harbor is presented in Figure 23. There have been no reports of needed repairs or rehabilitation since 1973.</p>

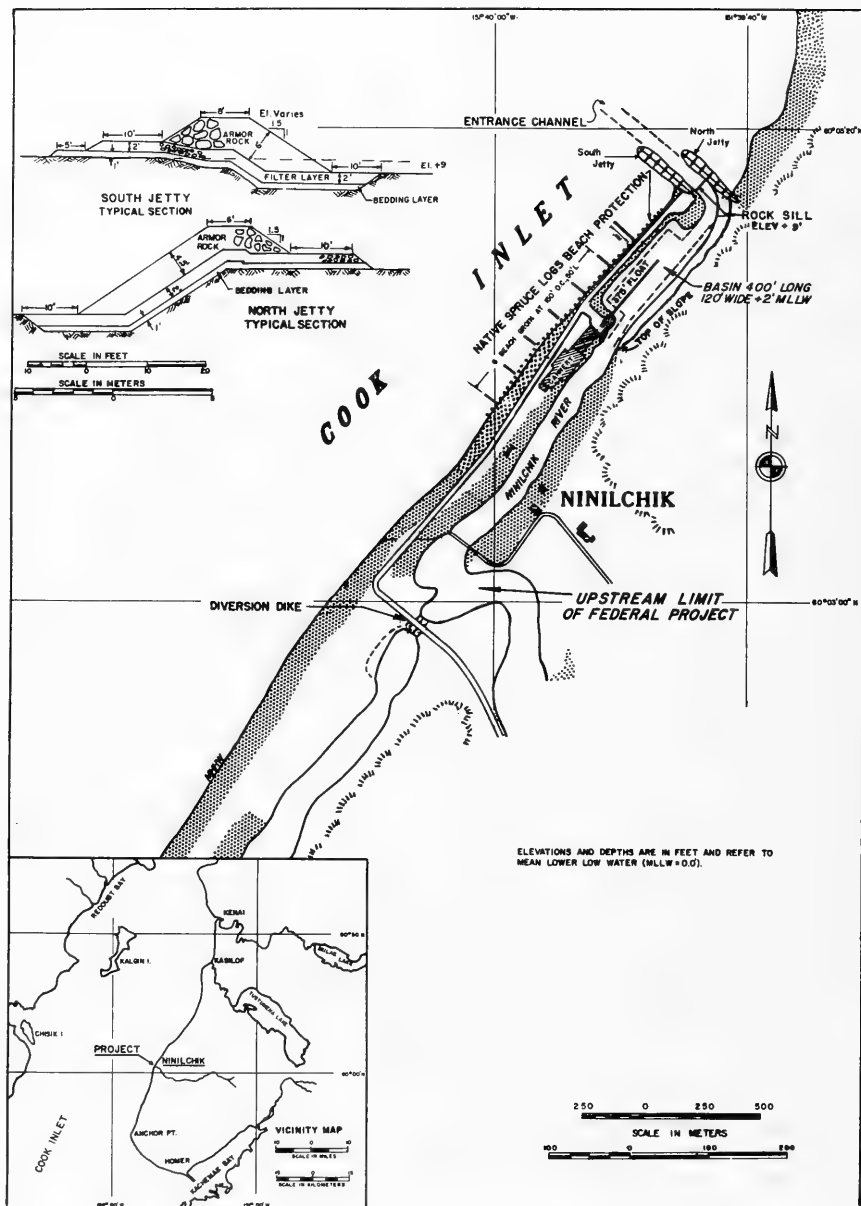
Figure 34. Layout of Ninilchik Harbor, Alaska (revised 1981)

1967	Major rehabilitation of the harbor was done. The Ninilchik River was diverted to its previous course south of the basin, and two short rubble-mound jetties were constructed at the river mouth. Jetty cross sections are shown in Figure 34.
1980	A study was authorized to determine the feasibility of harbor improvements.
1984	The study determined that improvements to the harbor would not be cost effective.
1985	The harbor is illustrated in Figure 34, and an aerial photograph of the harbor is presented in Figure 35. The harbor has required annual maintenance dredging and repairs since its construction.

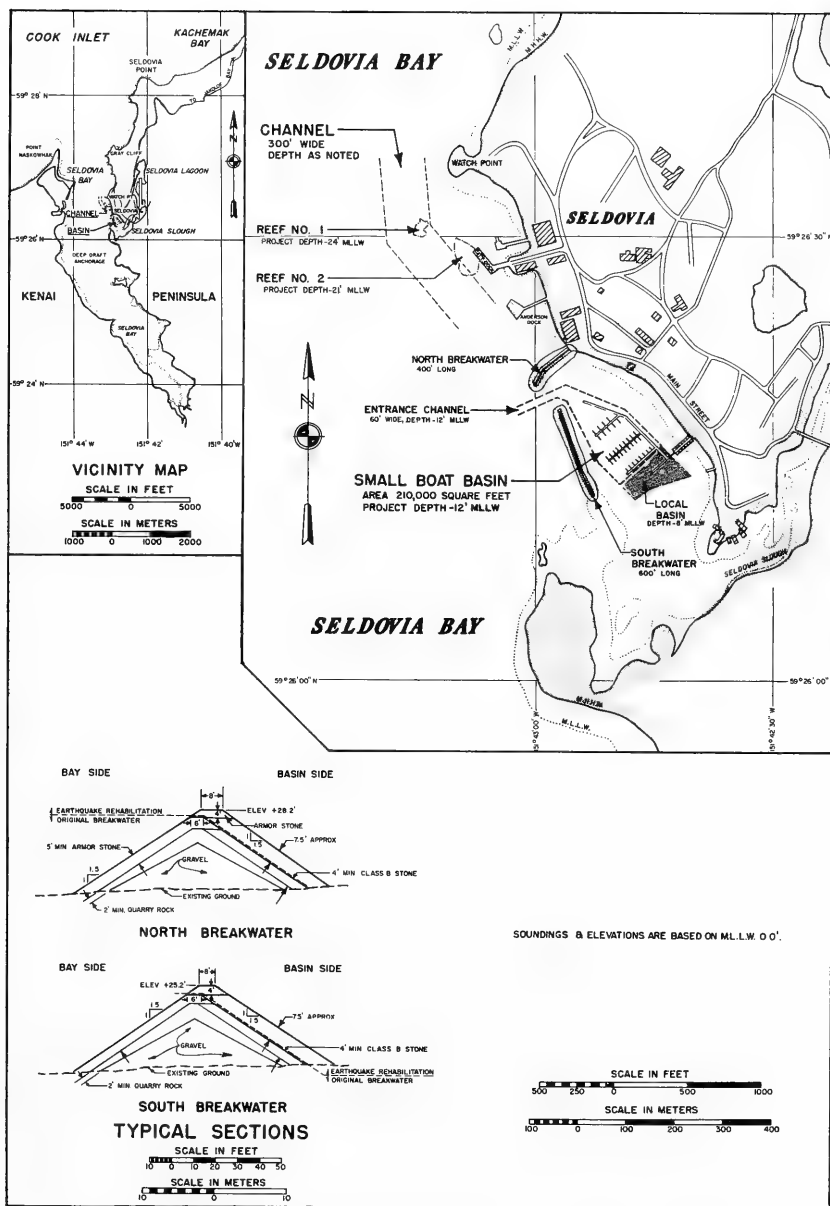
Figure 42. Site layout of Seldovia Harbor, Alaska (revised 1981)

1964	The basin subsided 3.8 ft in an earthquake. The breakwaters were repaired with a 7.5-ft-thick layer of rock on the basin side and a 4-ft-thick layer of armor rock on the crest, raising the crest elevations 0.2 ft over the original design heights, and widening the crests to 8 ft. The repair work required a total of 26,877 tons of stone. Cross sections of the rebuilt breakwaters are shown in Figure 42.
1985	The harbor is illustrated in Figure 42, and an aerial photograph of the harbor is presented in Figure 43. There have been no reports of needed repairs or rehabilitation since 1964.

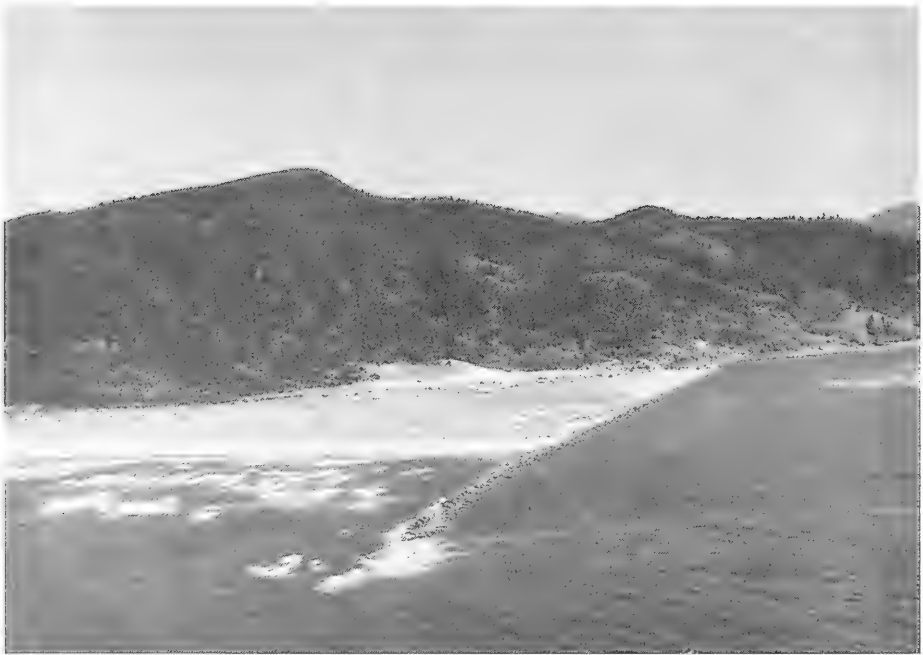
Figure 62. Aerial photograph of north jetty, Tillamook Bay, Oregon, 1955

Date(s)	Construction and Rehabilitation History
1978- 1979	The south jetty was extended to 8,000 ft.
1985	The harbor and cross sections of the jetties are illustrated in Figure 63. The head of the north jetty has received some damage from extreme wave conditions, and the outer portion of the south jetty has shown some subsidence. No repairs or rehabilitation are planned at this time.

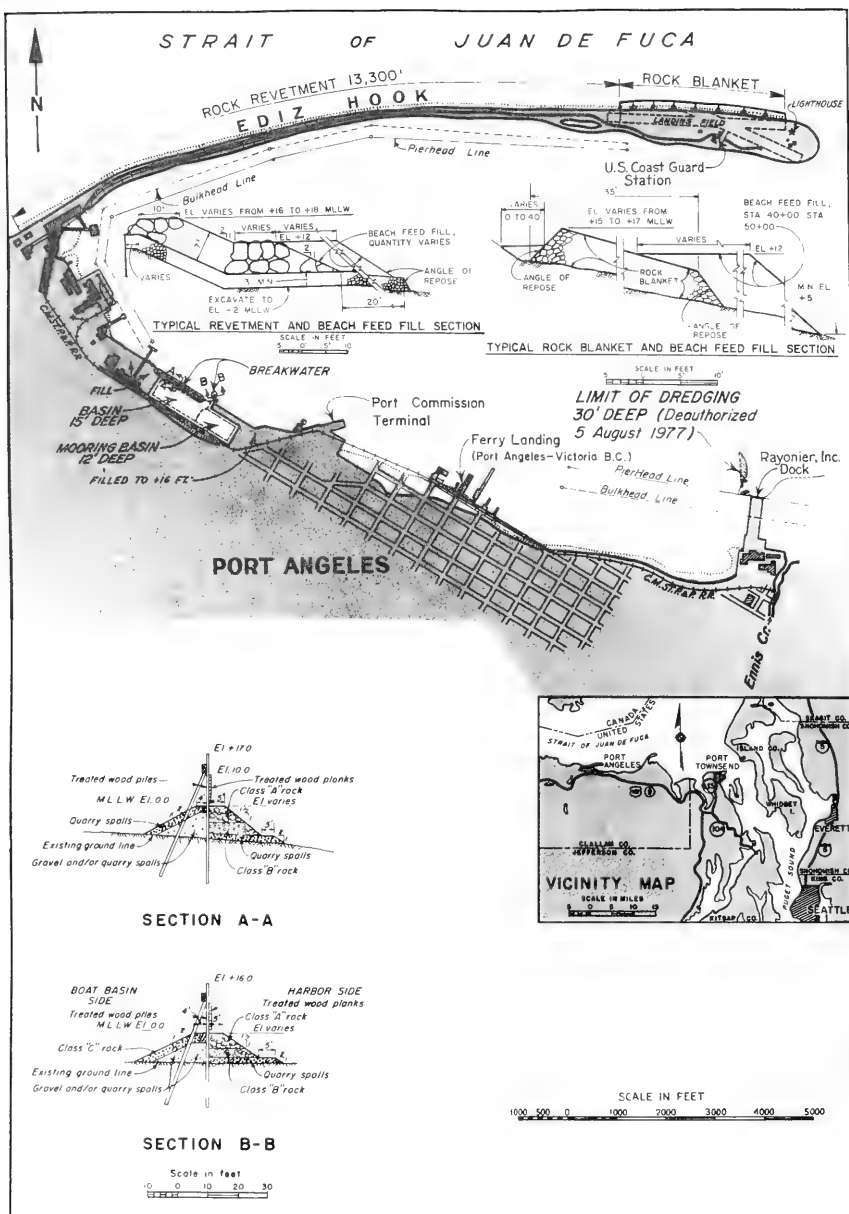
Figure 75. Site layout of Port Angeles, and Ediz Hook, Washington (revised 1979)

1985	The harbor and cross section of the breakwater are illustrated in Figure 75. There are no records of needed repairs or rehabilitation.

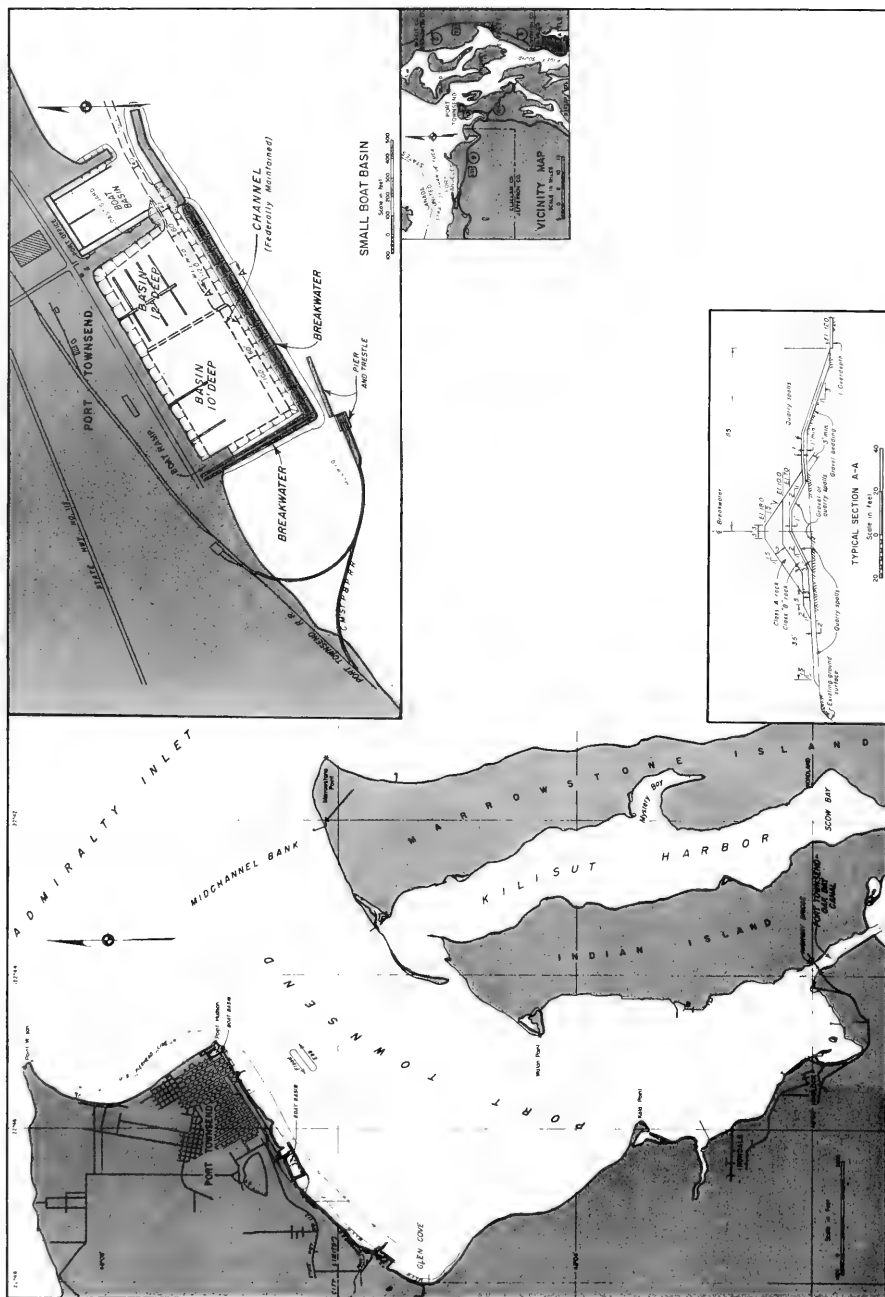
Figure 76. Site layout of Port Townsend, Washington (revised 1979)

<u>Date(s)</u>	<u>Construction and Rehabilitation History</u>
1958	Improvements to the small-boat basin were authorized.
1962	The final design recommendations were submitted.
1964	Construction of 1,946 ft of the rubble-mound breakwater and dredging of the adjacent basin were completed. The breakwater was constructed to +18 ft mllw for a 5-ft design wave. An access channel was cut through the existing breakwater to -12 ft mllw with a width of 50 ft at the bottom of the gap and side slopes of 1:2.
1985	The harbor and cross section of the breakwater are illustrated in Figure 76. There are no records of needed repairs or rehabilitation.

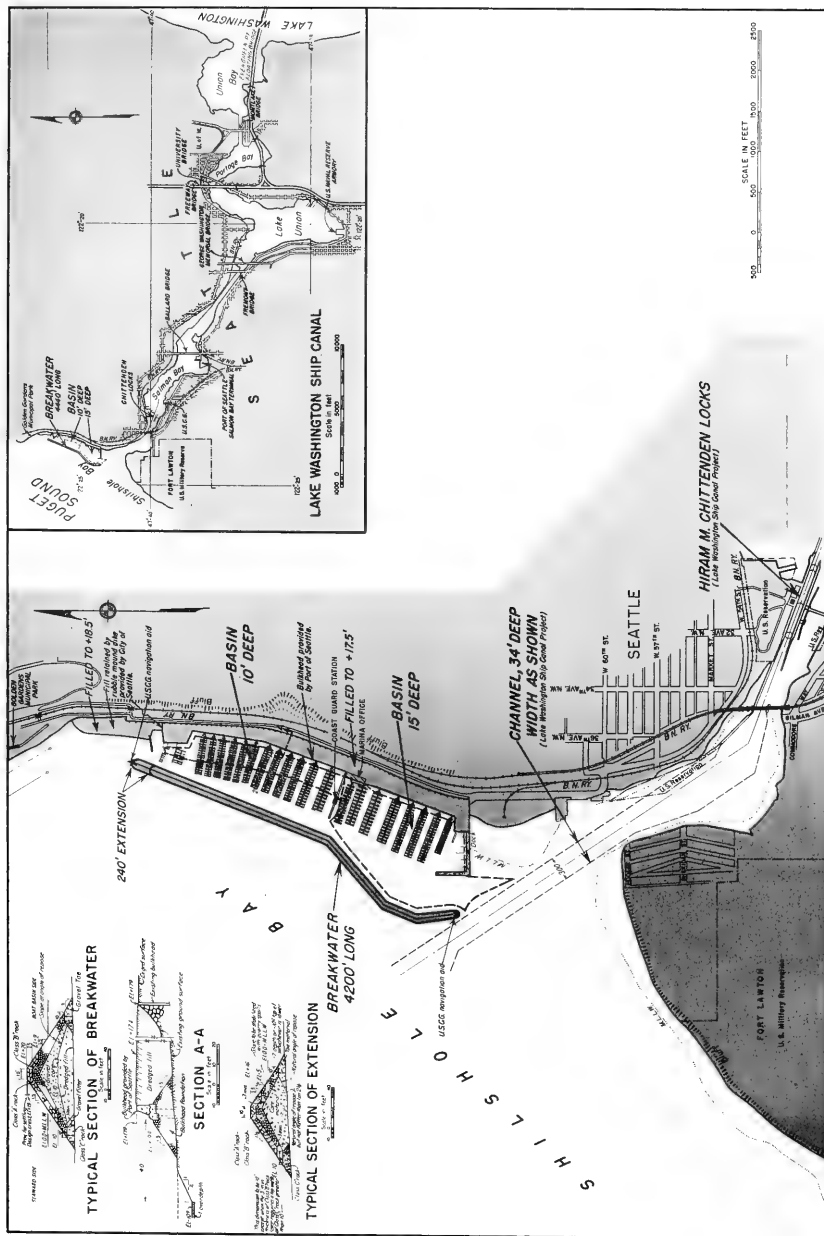
Figure 78. Site layout of Shilshole Bay, Washington (revised 1979)

1961	A 240-ft-long rubble-mound extension was added to the existing breakwater.
1985	The harbor and cross sections of the breakwater are illustrated in Figure 78. There are no reports of needed repairs or rehabilitation.

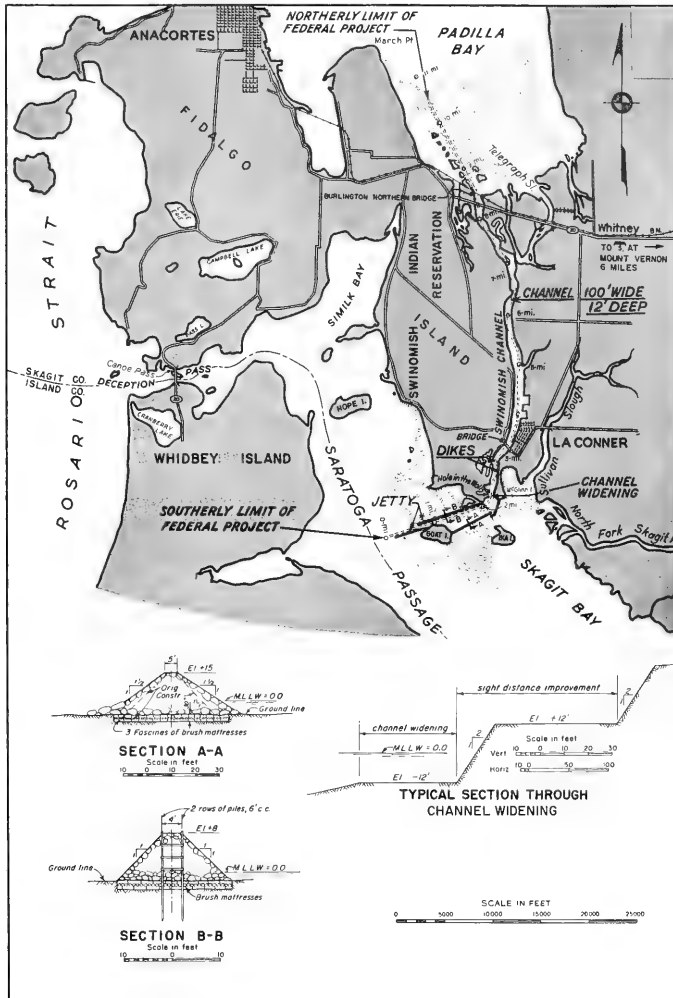
Figure 79. Site layout of Swinomish Channel, Washington (revised 1979)

Date(s)	Construction and Rehabilitation History
1985	The jetty layout and cross sections of the jetties are illustrated in Figure 79. The north jetty shows obvious deterioration, and the south jetty and Goat-McGlinn Island jetty appear in good condition.

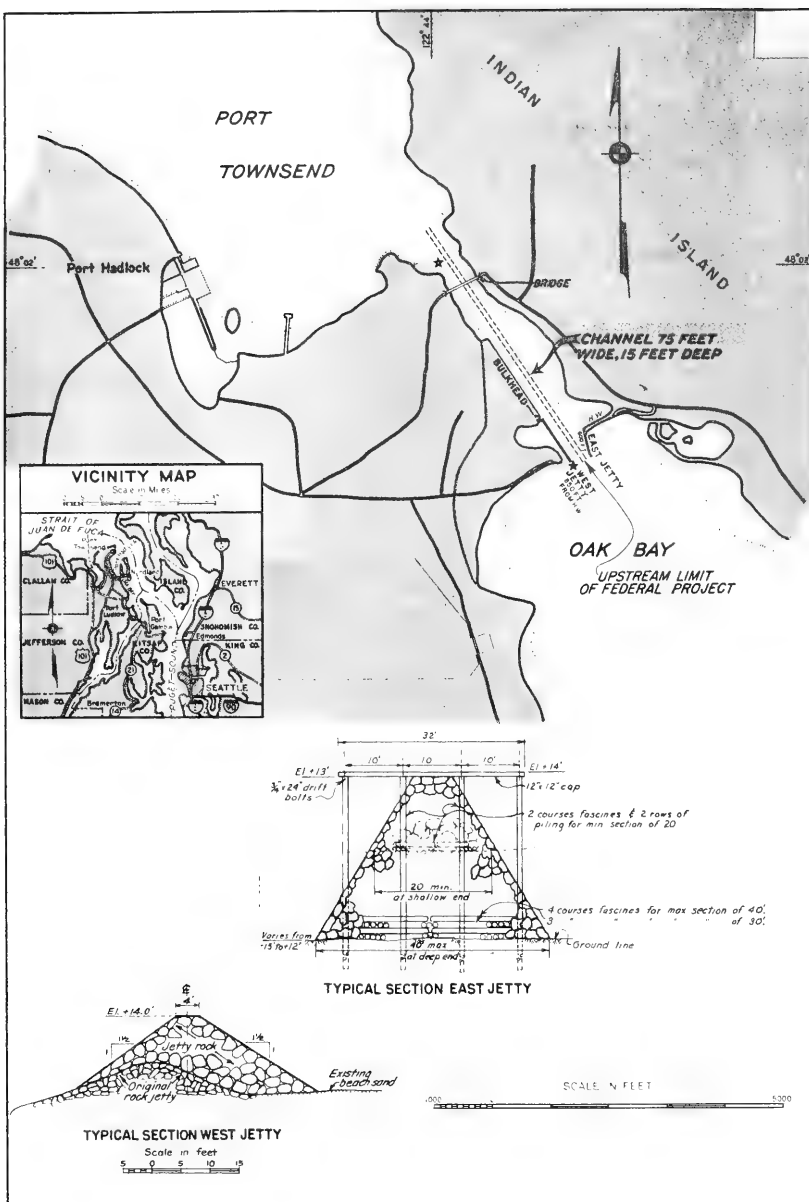
Figure 80. Site layout of waterway connecting Port Townsend and Oak Bay, Washington (revised 1979)

Date(s)	Construction and Rehabilitation History
1913	The project was adopted.
1915- 1916	The east jetty, west jetty, and bulkheads were constructed. The jetties were constructed of brush, pile, and stone with a 4-ft-wide crest and 1:1 side slopes. The west jetty was 550 ft long; the east jetty was 600 ft long. The bulkheads were constructed of brush, pile, and timber.
1925	The jetties and bulkheads were rehabilitated with 1,153 tons of rock.
1937	The rehabilitation work was performed on the east jetty by placing 393 tons of rock.
1961	The west jetty was rehabilitated with 12,173 tons of jetty rock to a crest elevation of +14 ft mllw, a crest width of 4 ft, and side slopes of 1:1.5.
1985	The jetty layout and cross sections are illustrated in Figure 80. There is no record of repairs or rehabilitation since 1961. The west jetty is in good condition. The east jetty shows some deterioration but is stable and functional.

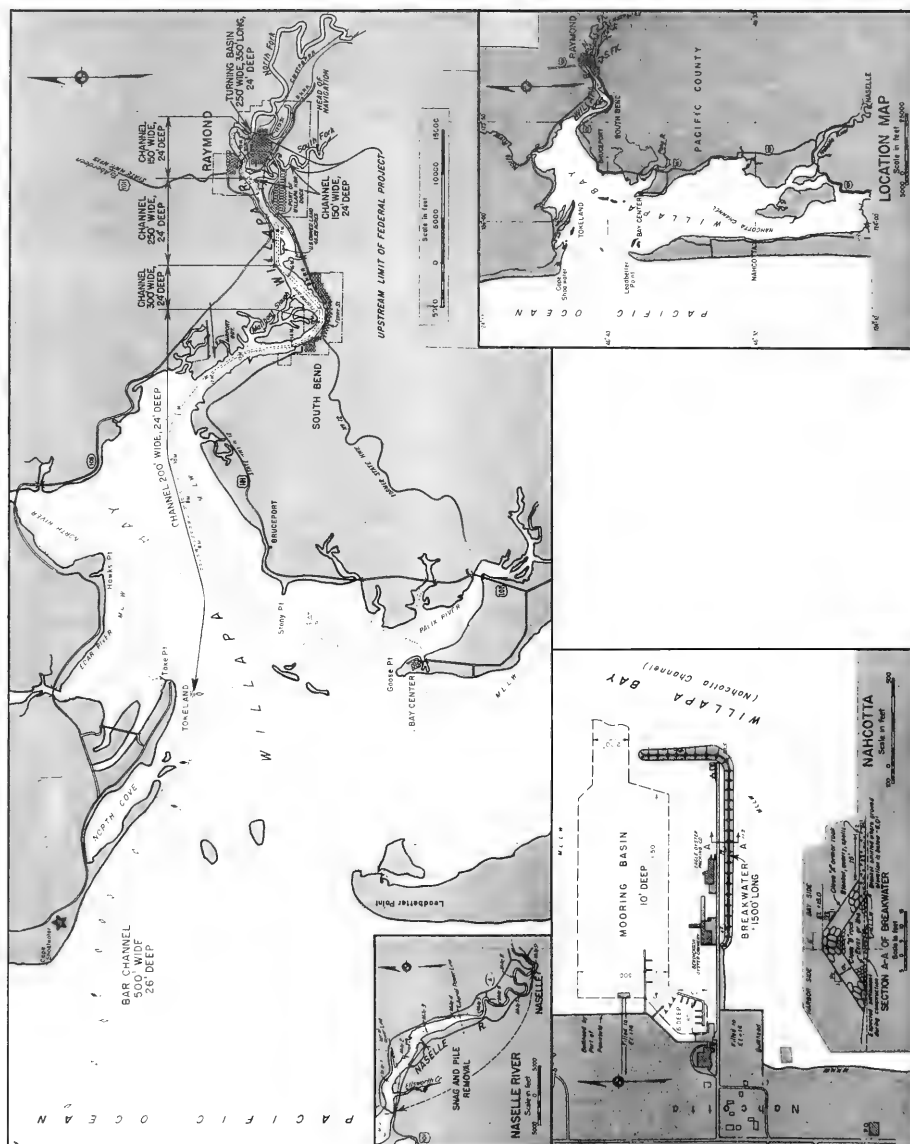
<u>Date(s)</u>	<u>Construction and Rehabilitation History</u>
1916	Willapa River and Harbor project adopted.
1954	The Willapa River and Harbor project was modified to include the mooring basin and the breakwater at Nahcotta.
1957	The breakwater design at Nahcotta was modified to conform to requests by local interests.
1957- 1958	The Nahcotta breakwater was constructed. The 1,500-ft-long breakwater was of rubble-mound construction, with the crest at elevation +15 ft mllw, width of 6 ft, and side slopes of 1:1.5. The landward end tied into an existing oystershell mound at the landward end of Nahcotta Wharf. A 2-ft-thick layer of quarry spalls was extended 15 ft from the seaward toe on the channel side of the breakwater to protect against toe scour. The breakwater required 43,700 tons of rock to complete.
1958	The Nahcotta mooring basin and channels were dredged.
1985	The harbor layout and breakwater cross sections are illustrated in Figure 82. There are no reports of needed repairs or rehabilitation for the breakwater.
